Contract #: 04-0120F4Cty: SF/ALA Rte: 80 PM: 13.2/13.9File #: 1.28**WELDING INSPECTION REPORT****Resident Engineer:**Siegenthaler, Peter**Address:** 333 Burma Road**City:** Oakland, CA 94607**Report No:** WIR-022498**Date Inspected:** 08-Apr-2011**Project Name:** SAS Superstructure**OSM Arrival Time:** 700**Prime Contractor:** American Bridge/Fluor Enterprises, a JV**OSM Departure Time:** 1530**Contractor:** American Bridge/Fluor Enterprises, a JV**Location:** Job Site

WELDING INSPECTION REPORT

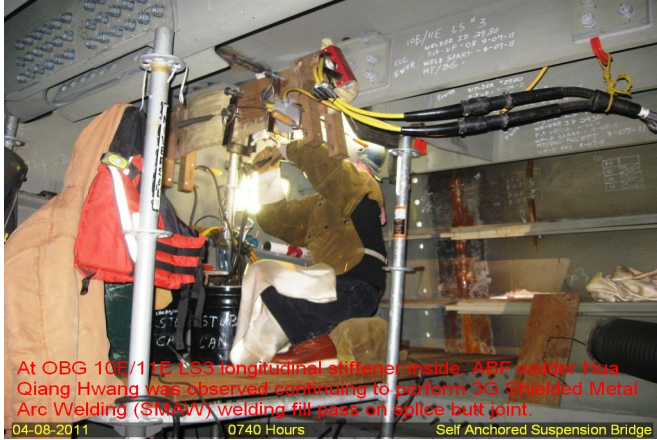
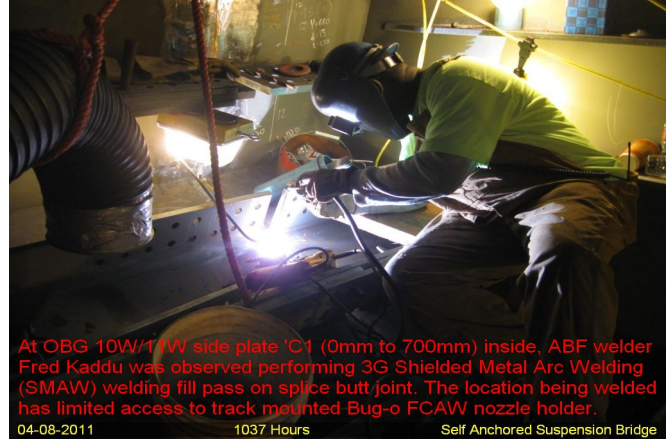
QA randomly observed ABF/JV qualified welders Rory Hogan (ID #3186) and Jeremy Dolman (ID #5042) perform CJP groove (splice) back welding cover pass on Orthotropic Box Girder (OBG) 9E/10E side plate 'E2' outside. The welder was observed welding in the 4G (overhead) position utilizing a dual shield Flux Cored Arc Welding (FCAW-G) with E71T-1M, 1/16" diameter wire electrode and implementing Caltrans approved Welding Procedure Specification (WPS) ABF-WPS-D15-3110-4. The welder was using a track mounted welder holder assembly that was remotely controlled. The joint being welded has the backing bar gouged using the Esab Plasma Arc machine and was ground smooth. The gouged and ground splice butt joint was also Non Destructive Testing (NDT) tested using the Magnetic Particle Testing (MT). The splice joint was preheated to greater than 150 degrees Fahrenheit using Miller Proheat 35 Induction Heating System located on top of the plate prior and maintained the preheat by moving the heater blankets on the side of the plate during welding. The vicinity was also properly protected from wind and other climatic changes. During welding, ABF Quality Control (QC) William Sherwood was noted monitoring the welding parameters of the welder. During the shift, cover pass welding at location mentioned above was completed and the welder has said he is moving to 9W/10W plates 'C', 'D' and 'E' but not sure which plate he is doing first.

At OBG 10W/11W side plate 'C' (0mm to 700mm) inside, QA randomly observed ABF/JV qualified welder Fred Kaddu perform root pass to cover pass welding on the Complete Joint Penetration (CJP) splice butt joint where the

track mounted Bug-o FCAW welder nozzle holder has limited access. The welder was observed manually welding in the 3G (vertical) position utilizing a Shielded Metal Arc Welding (SMAW) with 1/8" diameter E7018H4R electrode and implementing Caltrans approved Welding Procedure Specification (WPS) ABF-WPS-D15-1040B. The joint being welded has a single V-groove butt joint with steel backing bar. During welding, ABF Quality Control (QC) William Sherwood was noted monitoring the welding parameters of the welder. During the shift, cover pass SMAW welding was still continuing and should remain Monday.

At OBG 10E/11E LS3 longitudinal stiffener inside, QA randomly observed ABF welder Hua Qiang Hwang continuing to perform 3G (vertical) Shielded Metal Arc Welding (SMAW) complete joint penetration (CJP) welding fill pass to cover pass on the other side of the stiffener splice butt joint. The stiffener plates being welded are made of high strength plate material HPS 485W and has a thickness of 30mm. The joint has a double V joint preparation that was welded from one side and after the completion from one side, to be back gouged; Non Destructive Testing (NDT) tested using Magnetic Particle Testing (MT) and back welded to the other side. The welder was noted using E9018H4R with 1/8" diameter electrode implementing Caltrans approved welding procedure specification (WPS) ABF-WPS-D1.5-1012-3. The joint being welded was root welded using a ceramic backing. The splice joint was preheated to greater than 200 degrees Fahrenheit using Miller Proheat 35 Induction Heating System heater blanket located at the opposite side of the plate prior/during welding. The QA Inspector noted the ABF QC John Pagliero was on site monitoring the in process preheats and welding parameters. During the shift, QA noted ABF QC John Pagliero was closely monitoring the issuance of E9018H4R electrodes due to its limited exposure time allowed. During the shift, cover pass welding on both sides of the stiffener was completed and the welder was instructed by QC to hold and maintain the preheat of 200 ° F for three more hours after welding as required.
